**State of Louisiana
Department of Natural Resources
Coastal Engineering Division**

**2005/2006 Annual Inspection
Report**

**MARSH ISLAND HYDROLOGIC
RESTORATION PROJECT
(TV-14)**

October 10, 2005
Iberia Parish

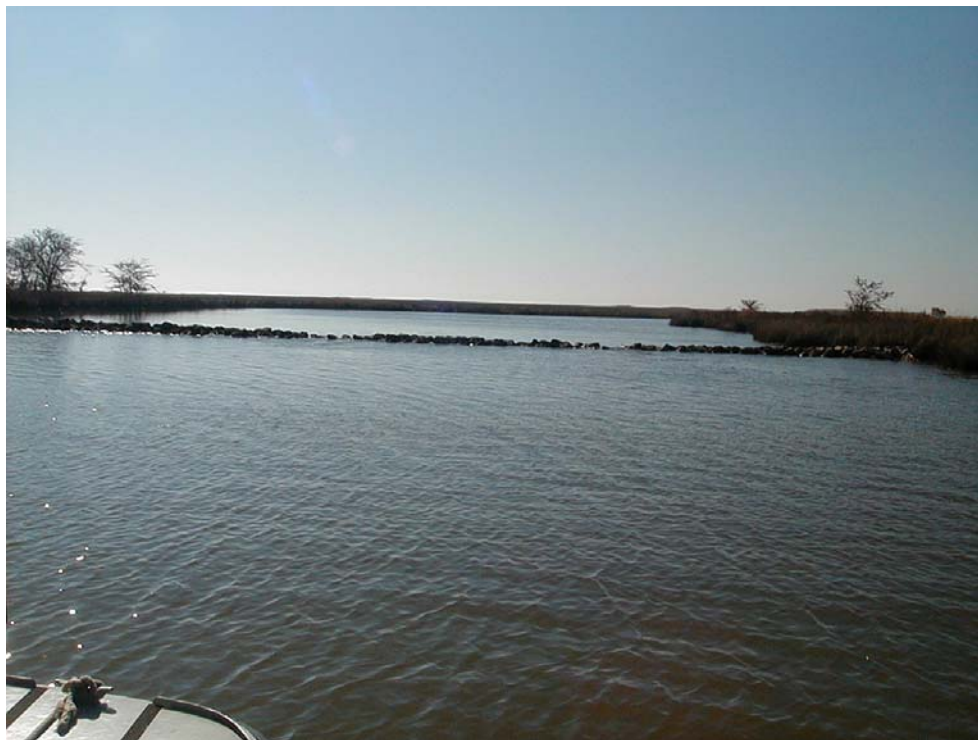
At the time of the inspection the water was high and there appeared to be two minor breaches at this closure site. However, a subsequent field trip at normal water elevation revealed that there are no breaches at this site. There is some erosion on each end where the rock plug ties back into the adjacent marsh. This condition will allow for additional erosion and eventual “flanking” of the canal closure. As a result of the inspection of Closure No. 1, LDNR and COE agree that corrective actions will be required this year. The marsh on each end of the closure should be paved with 15 “ of 110# stone to make this area “hard” and less subject to erosion and thereby prevent eventual flanking of the structure. (Photos: Appendix B, Photo 1).

Photo 1, Closure No.1, Note low areas of stone in center of structure.

Item	Condition	Physical Damage	Corrosion	Photo #	Observations and Remarks
Steel Bulkhead / Caps	N/A				
Steel Grating	N/A				
Stop Logs	N/A				
Hardware	N/A				
Timber Piles	N/A				
Timber Wales	N/A				
Galv. Pile Caps	N/A				
Cables	N/A				
Signage /Supports	N/A				
Rip Rap (fill)	Good	Minor		1	Some erosion on each end of rock plug, marsh paving will be required to prevent further erosion.
Earthen Embankment	N/A

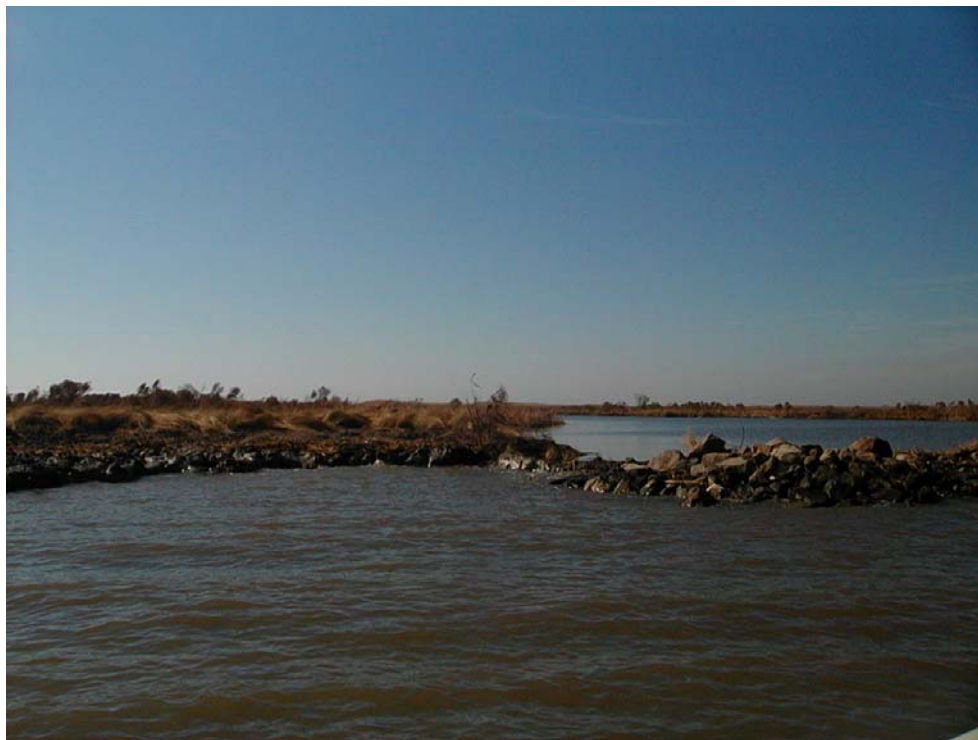
It was observed that extensive erosive damage to each end of the closure had occurred, especially on the east end, where there is now a major “flanking” cut that allows a water connection to the bay. The original rock structure that was constructed is still in good condition. LDNR and COE agree that maintenance will be required at this time. The closure dike needs to be extended on the east end to cut off and fill the flanking channel that was caused by Hurricane RITA. On the west end, the area that suffered erosion needs to be adjusted with some new stone paving. As a preemptive effort, the “new” ends of the closure dike should be paved and made “hard” as described for Closure No. 1. (Photos: Appendix B, Photo 2).

Photo 2, Closure No.2, View showing “flanking” cut on east end.

Item	Condition	Physical Damage	Corrosion	Photo #	Observations and Remarks
Steel Bulkhead / Caps	N/A				
Steel Grating	N/A				
Stop Logs	N/A				
Hardware	N/A				
Timber Piles	N/A				
Timber Wales	N/A				
Galv. Pile Caps	N/A				
Cables	N/A				
Signage /Supports	N/A				
Rip Rap (fill)	Fair	Moderate		2	Some erosion on east end of rock plug, marsh paving will be required to prevent further erosion. A flanking cut has occurred on the west end of the plug and will need to be extended.
Earthen Embankment	N/A

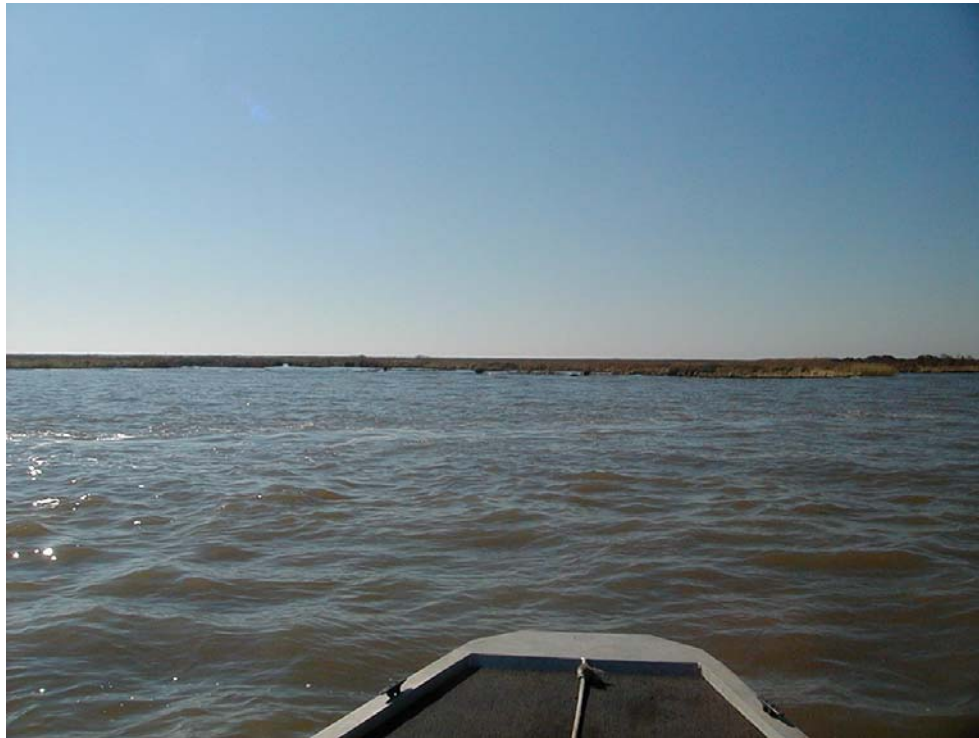
The rock closure dike appears in good condition and the stone appears to not have suffered major displacement. Also, it was observed (and confirmed with aerial photography post Hurricane RITA) that a large open water area has developed within the marsh near the western terminus of Closure No. 3 and that the bankline between that point and the eastern end of Closure No. 2 has eroded very severely and such that the “landbridge” between Vermilion Bay on the north of Marsh Island and the northwestern portion of Lake Sand proper is now narrow and may become subject to breaching thus allowing an undesirable water connection between the two bodies of water. LDNR and COE agree that this area is in poor condition and maintenance will be required at this time. It is suggested that an additional reach of shoreline protection dike be constructed, an estimated 1,500 to 1,800 linear feet, to connect the western end of Closure No. 3 to the eastern end of Closure No. 2. (Photos: Appendix B, Photos 3 & 4).

Photo 3, Area between West End of Closure No.3 and East End of Closure No.2, showing narrow section of marsh requiring shoreline protection.

Item	Condition	Physical Damage	Corrosion	Photo #	Observations and Remarks
Steel Bulkhead / Caps	N/A				
Steel Grating	N/A				
Stop Logs	N/A				
Hardware	N/A				
Timber Piles	N/A				
Timber Wales	N/A				
Galv. Pile Caps	N/A				
Cables	N/A				
Signage / Supports	N/A				
Rip Rap (fill)	Good			3 & 4	Hurricane RITA eroded the marsh between Str. No. 2 & 3, leaving a narrow piece of marsh, and it is recommended that the shoreline between Str. 3 & 4 (+/- 1,500 to 1,800 L.F.) be armored with a rock dike.
Earthen Embankment	N/A

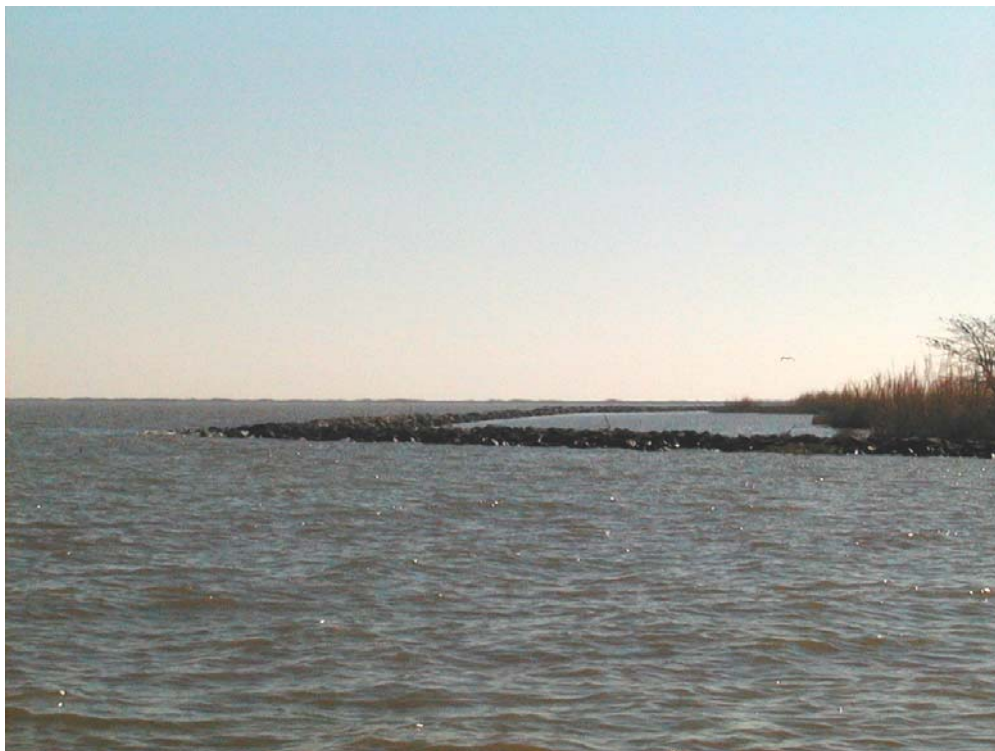
Photo 4, Closure No. 3, View looking east, Lake Sand Dike in the background.

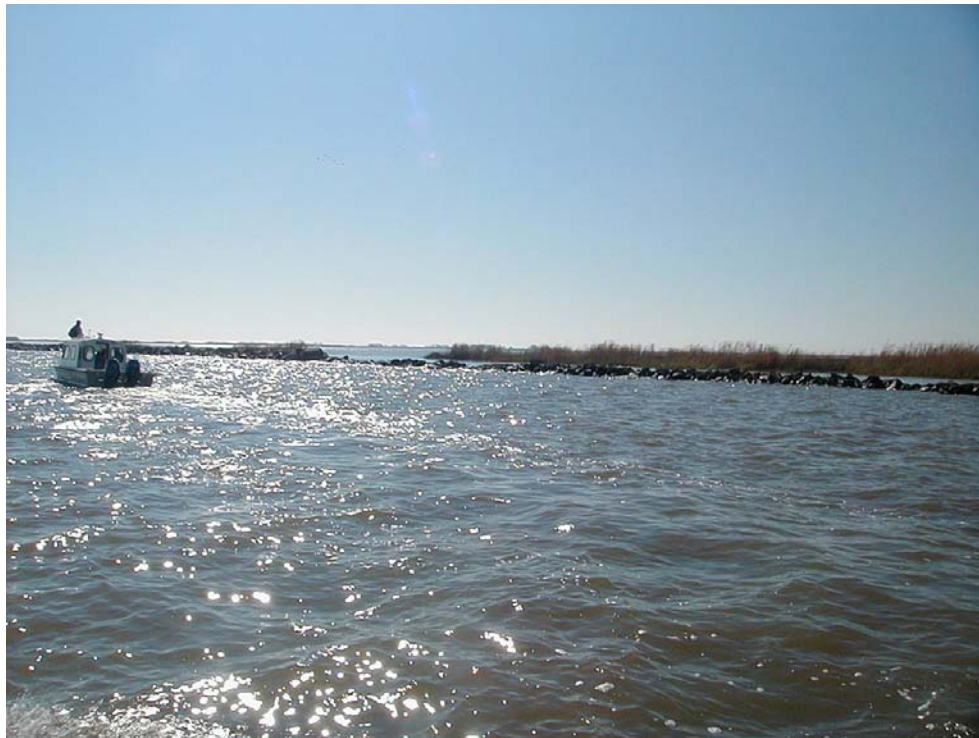
The Lake Sand Dike closure as originally constructed and recently repaired for Hurricane LILI damages, appears in good condition and the stone appears to have not suffered major displacement except for some of the eastern reach where some of the stone, which had existed to +4.0 NAVD88, appears to be a bit low in elevation. This latter reach is several hundred feet in length and the most easterly tie-in bank has been reduced in cross-section for 80 to 100 feet. LDNR and COE agree that this area is deficient and maintenance will be required at this time. The low areas described above in the reach within the old dike that was to +4.0 elevation will need to be restored with rock riprap. (Photos: Appendix B, Photo 5).

Photo 5, East end of Lake Sand Closure No. 4. Note low areas of stone.

Item	Condition	Physical Damage	Corrosion	Photo #	Observations and Remarks
Steel Bulkhead / Caps	N/A				
Steel Grating	N/A				
Stop Logs	N/A				
Hardware	N/A				
Timber Piles	N/A				
Timber Wales	N/A				
Galv. Pile Caps	N/A				
Cables	N/A				
Signage /Supports	N/A				
Rip Rap (fill)	Good	Minor		5	Several hundred feet of the rock dike on the eastern end has been displaced and will need to be restored to constructed height of +4.0.
Earthen Embankment	N/A

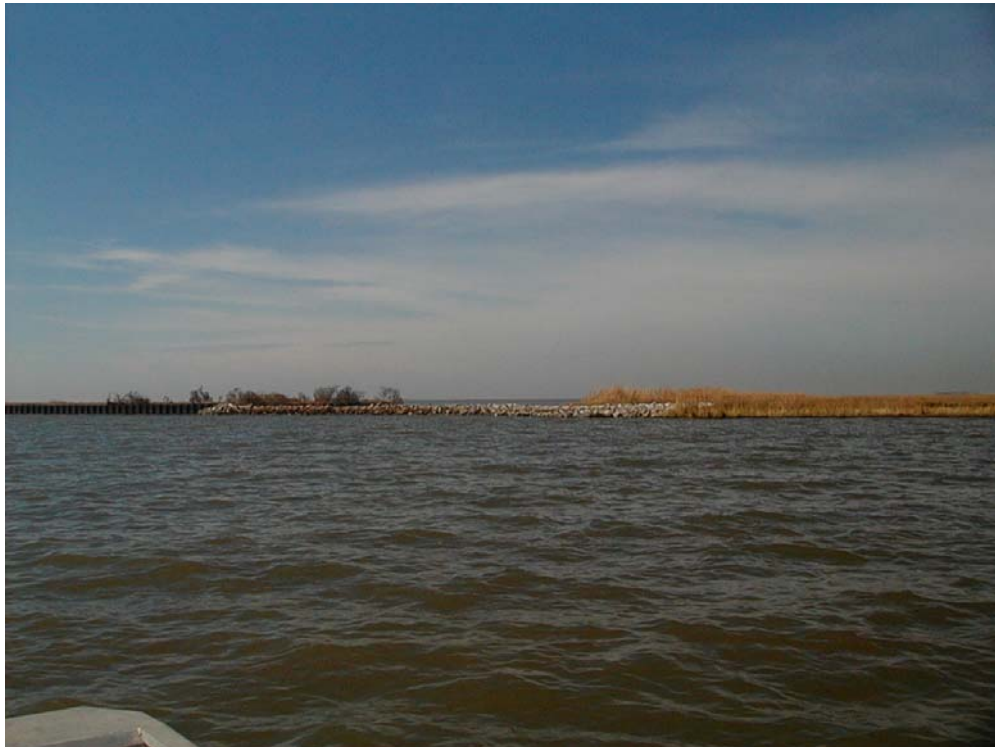
The inspection at Closure No. 5 revealed there had been some degradation of the earthen/marsh areas in the adjacent marsh. The steel sheet pile, rock riprap wingwalls, and stone bank/marsh paving placed as part of the Hurricane LILI repair project is in good condition and were apparently very effective in preventing additional damage by the erosive action of Hurricane RITA. The staff gage is now leaning and not readable. LDNR and COE agree that this area is deficient and maintenance will be required at this time. The staff gage needs to be re-set and made plumb to provide accurate readings. The overbank marsh areas recently paved to make same “hard” and paid for with O & M funding needs to be evaluated for its effectiveness. Marsh overbank areas, especially on the north end of the structure sustained much erosion in areas not protected by the “hard” paving, such that it is possible that the unpaved area to the north end of the closure may not be wide enough to withstand many more years without experiencing storm induced breaching. (Photos: Appendix B, Photo 6).

Photo 6, North end of Closure No. 5. View of northern portion of structure and of the repair work post Hurricane LILI prior to RITA landfall.

Item	Condition	Physical Damage	Corrosion	Photo #	Observations and Remarks
Steel Bulkhead / Caps	N/A				
Steel Grating	N/A				
Stop Logs	N/A				
Hardware	N/A				
Timber Piles	N/A				
Timber Wales	N/A				
Galv. Pile Caps	N/A				
Cables	N/A				
Signage /Supports	N/A				
Rip Rap (fill)	Good			6	Staff gage leaning, needs to be re-set. Marsh overbank area on the north needs to be evaluated for possible extended marsh paving.
Earthen Embankment	N/A

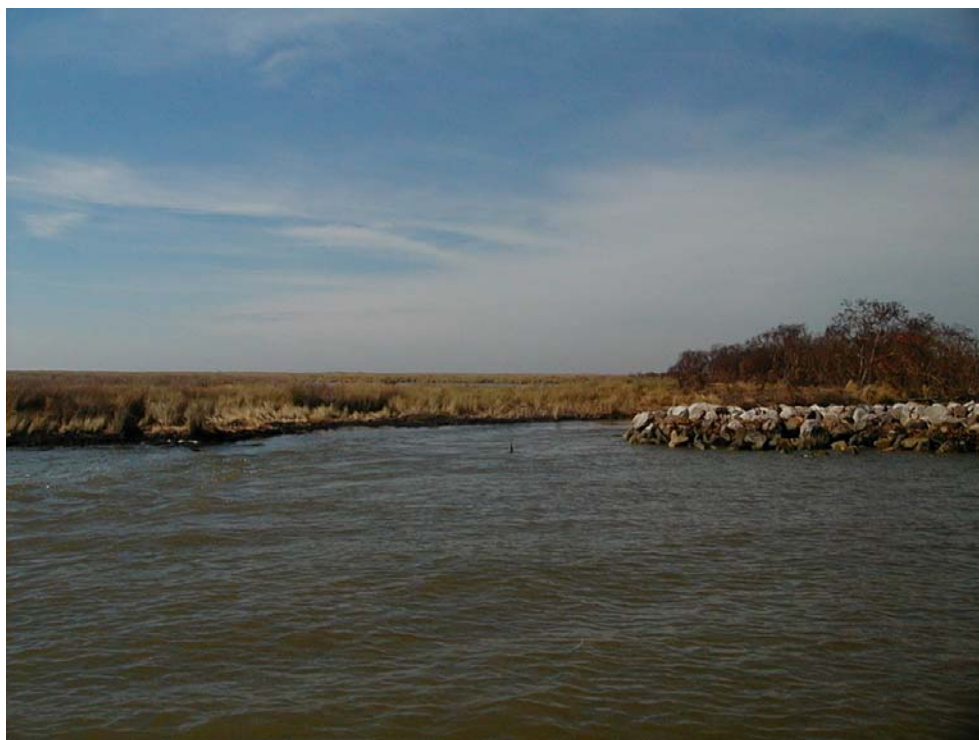
The initially constructed closure at this site still has an excellent cross-section, but the breach on the north end of the closure has been enlarged by Hurricane RITA. (Note: the breach was discovered approximately one month prior to RITA and was narrow and about two feet in depth). The breach is now larger, post RITA, and approximately one foot deeper in depth. On the south end of the closure, there was noted that some erosion of the marsh area was sustained at the dike tie-in location, to an extent that it is predicted that “flanking” of the closure will occur shortly. LDNR and COE agree that this area is deficient and maintenance will be required at this time. The existing flanking channel cut needs to be plugged off by extending the rock riprap closure to the north with stone. Cost should be shared with FEMA such that a channel breach existed pre-RITA. It is the opinion of this office that the cost sharing proportions would be equitable if shared at 1/3 State and 2/3 FEMA as the storm event made the pre-existing flanking breach wider and deeper in about those proportions. Also, as a recommended additional preemptive work, each resulting end of the closure dike should be paved and made “hard” per discussion for Closure No. 1. (Photos: Appendix B, Photo 7).

Photo 7, Closure No. 6. Note breach on north end of closure stone fill. Breach had begun prior to Hurricane RITA, but was not as wide.

Item	Condition	Physical Damage	Corrosion	Photo #	Observations and Remarks
Steel Bulkhead / Caps	N/A				
Steel Grating	N/A				
Stop Logs	N/A				
Hardware	N/A				
Timber Piles	N/A				
Timber Wales	N/A				
Galv. Pile Caps	N/A				
Cables	N/A				
Signage /Supports	N/A				
Rip Rap (fill)	Poor	Major		7	The existing breach on the northern end has increased in size and depth and needs to be plugged. Some erosion on southern end of rock plug which will need marsh paving to harden this area.
Earthen Embankment	N/A

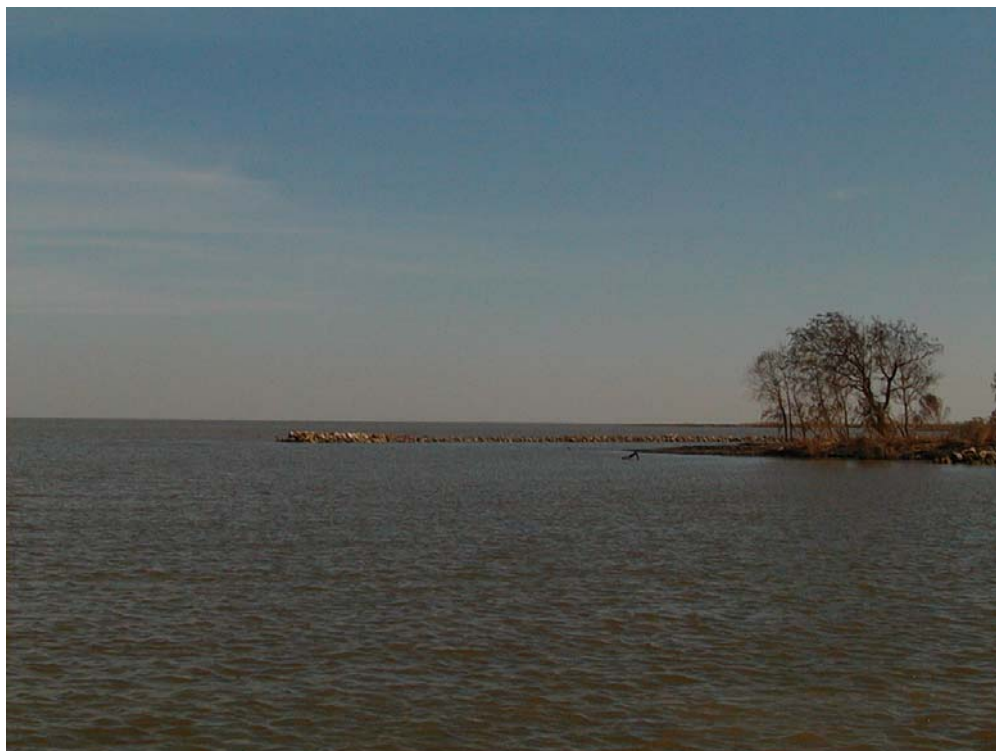
This closure site is in good condition except that the bank areas at both ends of the rock riprap have experienced some minor erosion. The closure tie-ins to the bank, however, appear still adequate at this time. LDNR and COE agree that this area is in good condition and no maintenance will be required at this time. (Photos: Appendix B, Photo 8).

Photo 8, Shoreline protection at Site No. 7.

Item	Condition	Physical Damage	Corrosion	Photo #	Observations and Remarks
Steel Bulkhead / Caps	N/A				
Steel Grating	N/A				
Stop Logs	N/A				
Hardware	N/A				
Timber Piles	N/A				
Timber Wales	N/A				
Galv. Pile Caps	N/A				
Cables	N/A				
Signage /Supports	N/A				
Rip Rap (fill)	Good			8	
Earthen Embankment	N/A

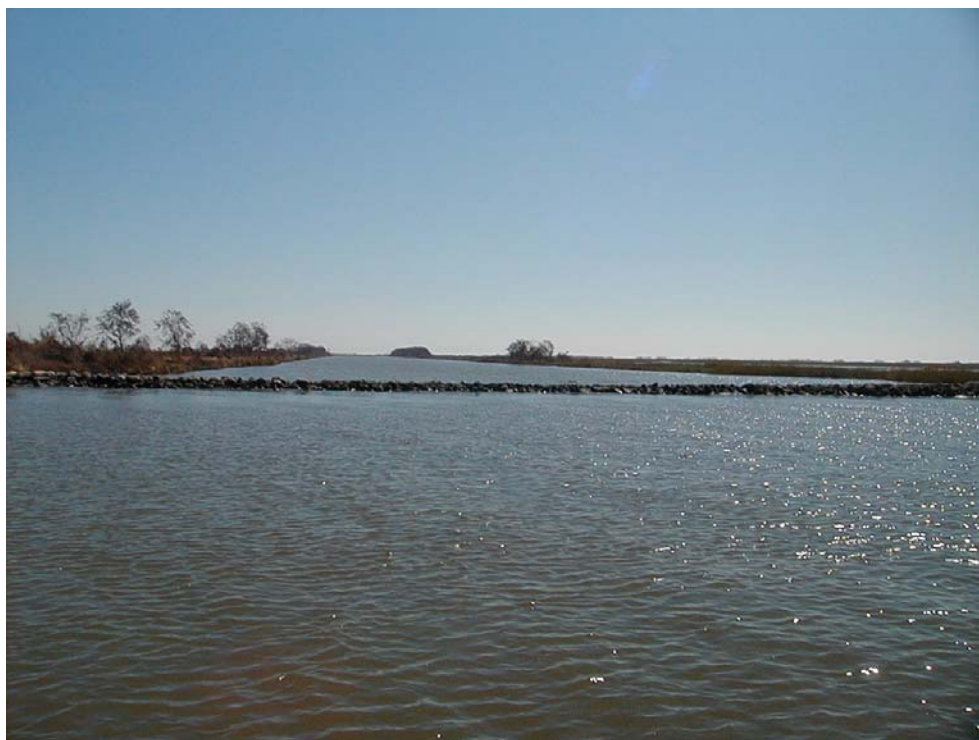
This closure site is in good condition and no damage was noted. LDNR and COE agree that this project feature requires no maintenance at this time. (Photos: Appendix B, Photo 9).

Photo 9, Closure No.8, View looking east.

Item	Condition	Physical Damage	Corrosion	Photo #	Observations and Remarks
Steel Bulkhead / Caps	N/A				
Steel Grating	N/A				
Stop Logs	N/A				
Hardware	N/A				
Timber Piles	N/A				
Timber Wales	N/A				
Galv. Pile Caps	N/A				
Cables	N/A				
Signage /Supports	N/A				
Rip Rap (fill)	Good			9	
Earthen Embankment	N/A

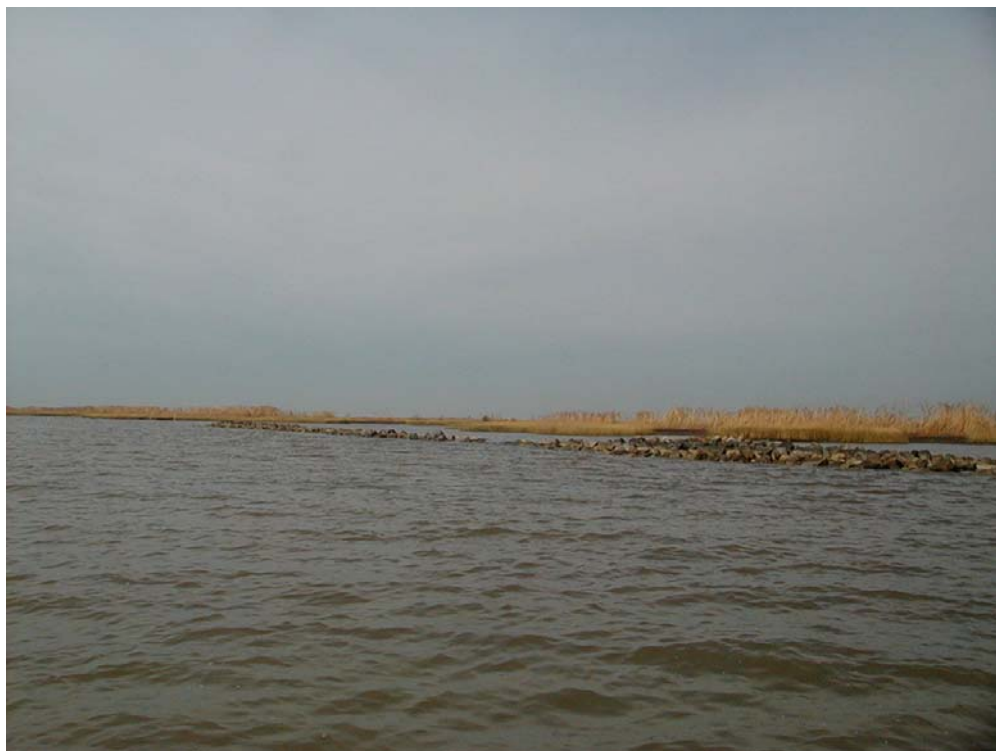
The rock riprap shoreline protection dike constructed on the south shoreline of Marsh Island was noted to now sit out further into the waters of the Gulf. Conditions that existed pre-RITA were such that the feature was functioning well and that sediment had accreted and a growth of marsh vegetation had extended over the new fill. The “newly” created marsh fill area is now severely broken-up and the original shoreline has receded to the north for a short distance. This rock shoreline feature will still function as a breakwater and extend the life of the earthen pipeline closure to the north, but it is probable that the shoreline protection dike is now too short, since the island shoreline has receded some to the north. The attacking wave energy will now be able to reach further to the middle of the shoreline initially protected, thus causing an increase of erosion to the earthen pipeline closure that was intended to be protected. LDNR and COE agree that this area is deficient and maintenance will be required at this time. The corrective work to be performed, the type and extent of which, has yet to be determined. It was discussed that perhaps each end of the current rock riprap dike be extended to the east and to the west, or perhaps construct extensions on each end of the existing stone to the northwest and northeast alignment directions to the shoreline from erosion of the earthen pipeline closure. Conditions at this location need to be evaluated and a design concluded after some study. (Photos: Appendix B, Photo 10).

Photo 10, Closure No. 9, Along south shore of Marsh Island. Note that shoreline protection dike is now away from the current shoreline post-RITA.

Item	Condition	Physical Damage	Corrosion	Photo #	Observations and Remarks
Steel Bulkhead / Caps	N/A				
Steel Grating	N/A				
Stop Logs	N/A				
Hardware	N/A				
Timber Piles	N/A				
Timber Wales	N/A				
Galv. Pile Caps	N/A				
Cables	N/A				
Signage /Supports	N/A				
Rip Rap (fill)	Poor	Moderate		10	Hurricane RITA has eroded the marsh/sediment behind the rock plug and has exposed the earthen keyway to further erosion. The rock dike needs to be extended on each end and tie back into existing shoreline.
Earthen Embankment	N/A
